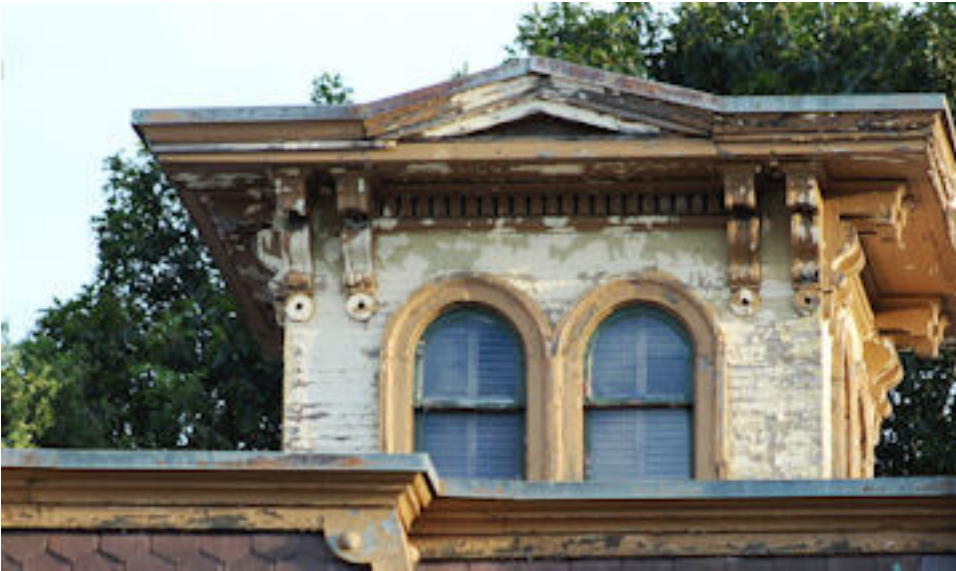
Left: Weather beaten and deteriorated window sashes, soffits and brackets on Widow's Walk  
Above: Peeling decorative trim

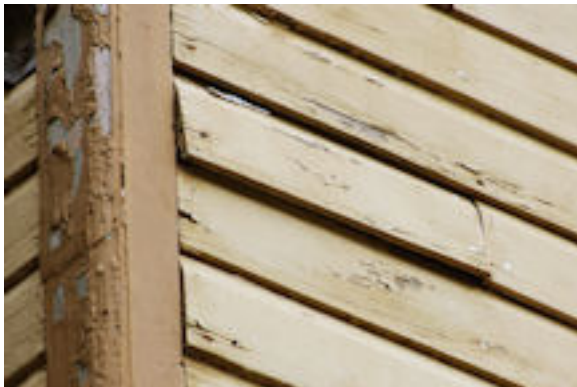
Above: Delaminating clapboards and exposed corner boards  
Near right: Wall junction showing rotted and separated siding trim  
Far right: Rotted ballister

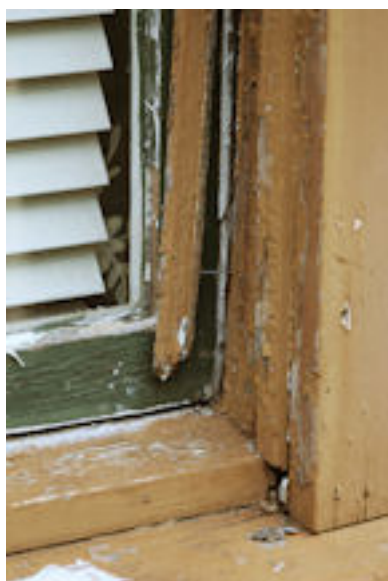
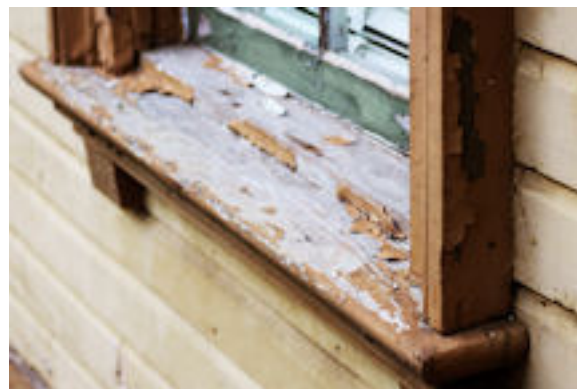
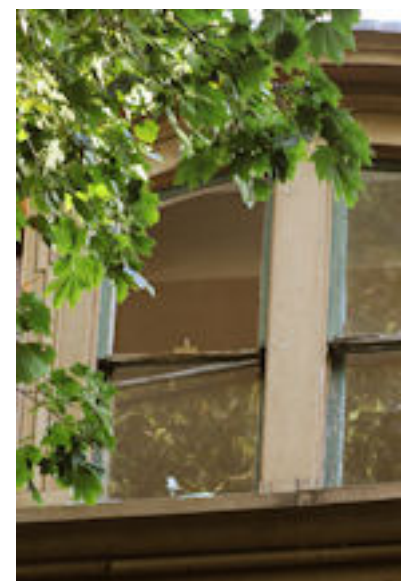
Windows and sills: Typical weather damaged and exposed windowsill and trim; separated boards and braces
